**DRAFT REPORT
ROUND 7 DAM ASSESSMENT
ASSOCIATED ELECTRIC COOPERATIVE, INC.
NEW MADRID POWER PLANT
ASH POND 1 & 2 AND SLAG POND 1 & 2 IMPOUNDMENTS
NEW MADRID COUNTY, MISSOURI**

January 14, 2011

Re: Round 7 Dam Assessment - Draft Report
EPA Contract No. EP10W001313
Associated Electric Cooperative, Inc. New Madrid Power Plant
Ash Pond 1 and 2 Impoundments and Slag Pond 1 and 2 Impoundments
New Madrid County, Missouri

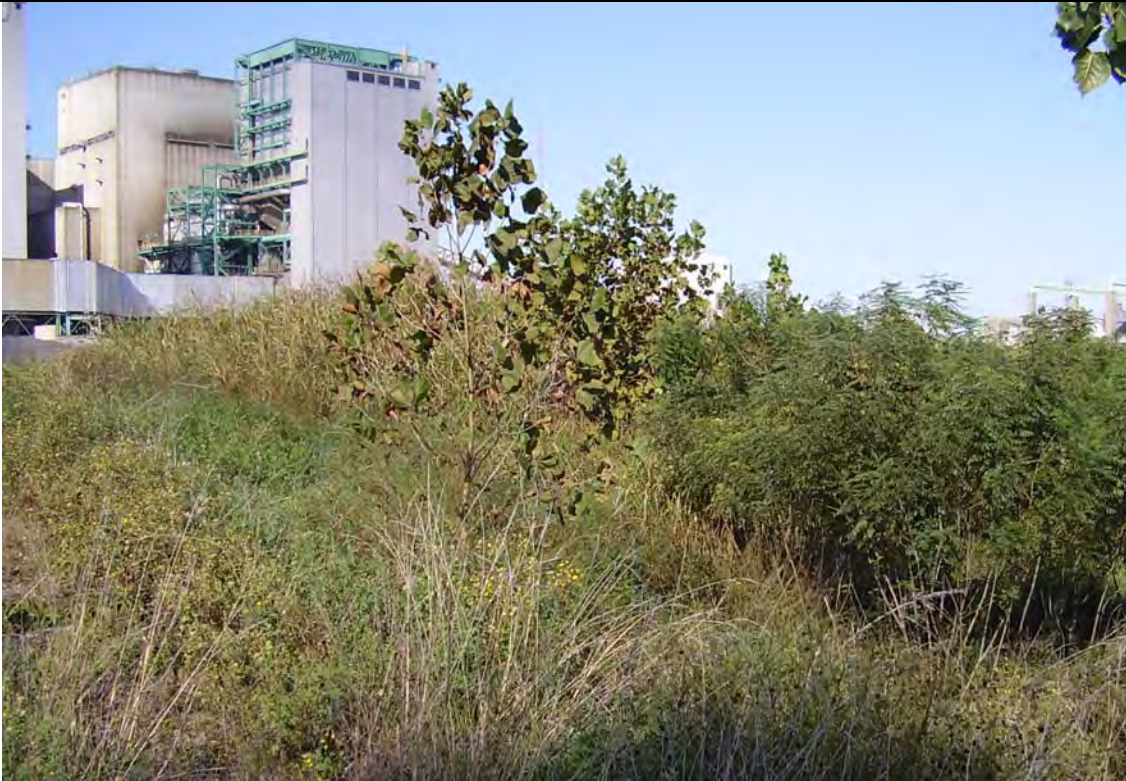
Client Name: U.S. EPA		Site Location: New Madrid Generating Facility Marston, Missouri	Project No. 01.0170142.20
Photo No. 21	Date: 10/6/10

A photograph showing a large industrial facility, likely a power plant, with tall smokestacks and complex piping. The facility is partially obscured by a dense line of trees and tall grass in the foreground. The sky is clear and blue.	
Direction Photo Taken: West			
Description: Trees present on the downstream slope of the northeast portion of the SP2.
